Bacteria-based self-healing concrete: evaluation of full scale demonstrator projects

Renée M. Mors^{a,b}, Henk M. Jonkers^{a*}

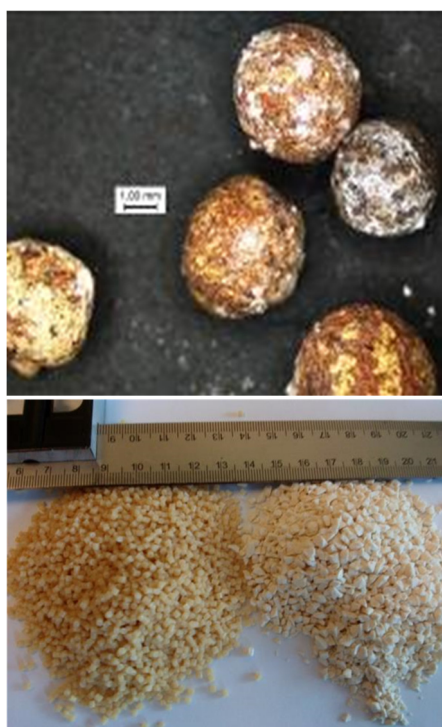
Figure 3. First generation expanded clay based healing agent (top image) and next generation lactate-derivative based healing agent (bottom image).

The functional components of the bacteria-based self-healing agent as developed by the Delft research group consist of bacterial spores and nutrients. The bacterial spores resist and survive incorporation in concrete while the nutrients are required for spore germination (conversion of metabolically inactive spores into active vegetative cells) and as precursor material for the limestone to be produced [13]. In initial studies the nutrients consisted of yeast extract for germination of spores and calcium lactate as limestone precursor compound and these two components were together with bacterial spores loaded into expanded clay-based porous aggregates (Fig. 3) [16]. Latter aggregates thus served as carrier material for the active healing agent components. Advantage of use of a porous carrier is that it

forms, in comparison to regular aggregates, weak spots in the concrete matrix which attract forming cracks. The cracks that hit and split porous aggregate particles thus ensure effective release of embedded active healing agent compounds into the crack [18, 19]. Disadvantage of use of porous carrier aggregates is that they significantly lower the compressive strength of the concrete [16, 20]. A next generation self-healing agent was therefore developed by the Delft group and in this one the active healing agent components (bacterial spores, yeast extract and lactate-derivatives) were pelleted using combined powder compression- and extrusion techniques which made the use of expanded clay carriers redundant [14]. Major advantage of the new generation healing agent is that it consists of 100% bio-based active ingredients not resulting in decrease of compressive strength of the resulting concrete if dosed correctly [21]. Activator of the healing agent is crack-ingress water what initiates germination of the bacterial spores. Metabolically active cells subsequently convert the lactate-derivatives into calcium carbonate-based insoluble minerals which, when sufficiently formed, block and waterproof cracks. Application fields of the bacteria-based healing agent are therefore limited to concretes exposed to moist conditions as water is required for the activation of the system as was established in documented studies [16, 17, 21-23]. Activation (germination) of the applied alkaliphilic bacterial spores occurs in pH range from 8 to 11.5 [2]. As the pH of the concrete mix during preparation and casting is well above 11.5, activation of the spores does not occur at this stage but only when pH drops below 11.5 due to external water that ingress cracks [24].

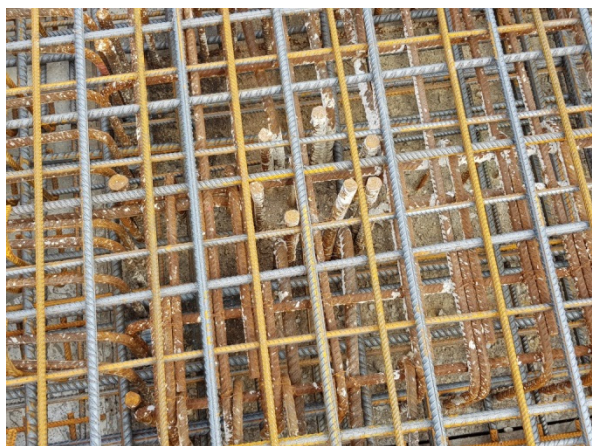
Figure 4. Picture of a finely meshed reinforcement network for watertight concrete constructions impeding easy casting of concrete.

Constructions in wet environments can specifically benefit from self-healing of cracks [27, 28]. Watertight constructions are commonly designed in such a way that only cracks of smaller than 0.1 mm width are allowed to occur as these are expected to self-heal due to autogenous healing capacity of the concrete [3]. Such designs, however, require a lot of crack width restraining reinforcement in addition to structural reinforcement steel. Disadvantage of applying abundant steel is nevertheless threefold: expensive, featuring high CO₂ footprint, and finely meshed network hampers easy casting of the concrete mix (Fig. 4). Instead, designing watertight constructions for marine- and freshwater applications, allowing crack widths of >0.1 up to 0.4 mm would save crack restraining steel. This will result not only in more economic structures but additionally also to lower CO₂ footprint structures with increased ease of placement of the concrete mix. Latter will allow to work faster and will also lower the risk of forming gravel nests and hollow spaces in the structure. Water tightness of these structures will be delivered by autonomous crack-sealing of mixtures requiring a dosage of 5 to 8 kg/m³ healing agent.

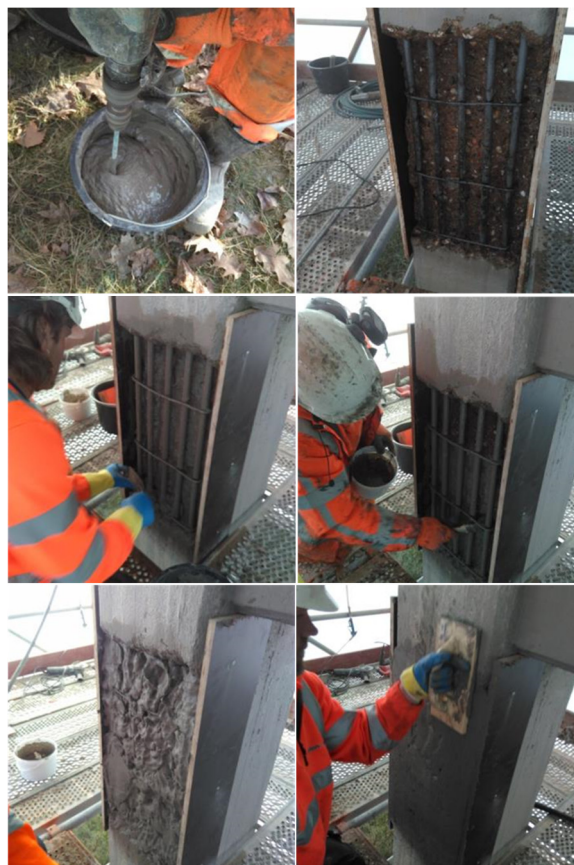
Figure 5. On site structural repair of damaged steel reinforced concrete column with bacteria-based self-healing repair mortar.

The developed bacteria-based self-healing repair mortar developed by the Delft research group was applied in two full scale projects in order to demonstrate practical applicability and functional performance. Projects were selected to demonstrate structural repair applicability and delivery of water tightness of cracked concrete basement walls respectively. In the first project the concrete cover of damaged steel reinforced concrete columns were replaced. Therefore, on site at the chemical plant 'Chemelot', located in Limburg, The Netherlands, the damaged cover zone up to 4 cm depth behind the embedded rebars was removed and replaced with bacteria-based self-healing repair mortar (Fig. 5). The repair mortar was classified as structural repair mortar R3, suitable for structural repair of concrete with a required compressive strength of up to 45 MPa.

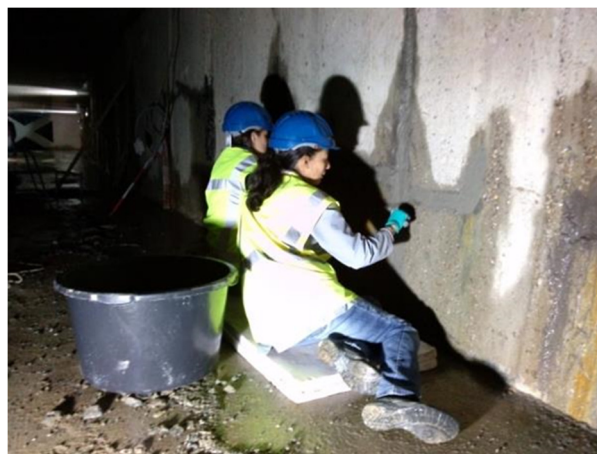
Figure 6. Manual repair of actively leaking cracked concrete basement walls using bacteria-based self-healing repair mortar.

The second project involved repair of cracked and actively leaking parking garage basement walls located 20 meter below ground level of the 'Groningen Forum' building, located in Groningen, The Netherlands. Before application of the bacteria-based self-healing repair mortar, present actively water-leaking cracks were cut open to a depth of 5 cm to provide sufficient bond surface for the to be applied repair mortar. Water flow was temporarily stopped through application of a 5-mm thick layer of fast setting cement, immediately followed by manual application of the repair mortar by filling up the crack cavities to level concrete surface (Fig. 6).

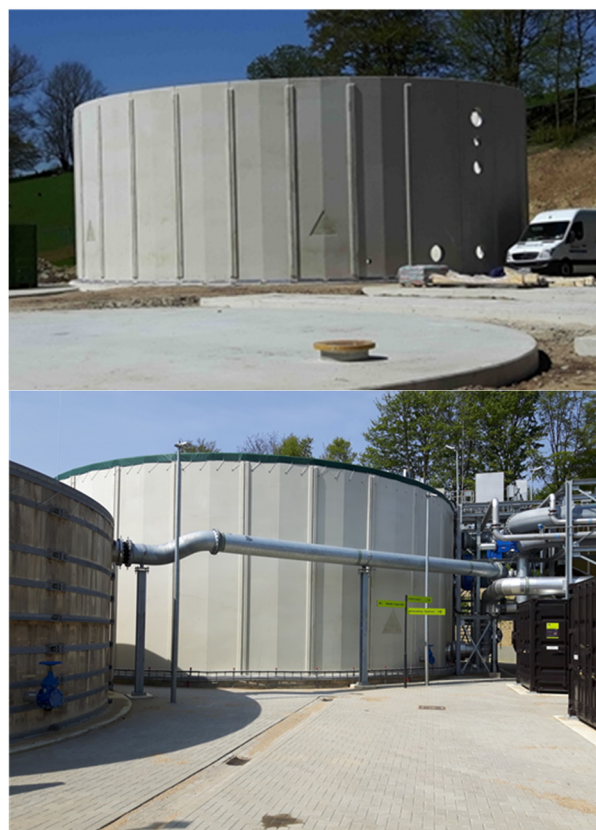
Figure 7. Prefabricated wastewater treatment tank under construction (top image) and in service (bottom image). Prefab elements bearing the triangular logo contain self-healing agent while the other, reference elements, do not.

By the Delft research group two full scale demonstrator projects with bacteria-based self-healing concrete were executed. The first one concerned construction of a wastewater purification tank consisting of precast concrete elements. This project was carried out in collaboration with the Water Boards authority Limburg (WBL), the Netherlands. The WBL's question was whether the application of self-healing concrete could lead to a reduction in cost-of-ownership, i.e. costs that are incurred over the entire life cycle of a construction. In particular, maintenance and repair costs of traditional concrete structures are high (typically 50% of WBL budget is spent on maintenance of current assets and 50% on building new constructions) and the use of self-healing concrete can potentially result in costs saving due to reduced need for repair in combination with an increased life time of the construction. Therefore it was decided to carry out a demonstrator project in the form of a wastewater treatment tank. The tank, consisting of prefab elements with dimensions of 7.00 x 2.50 x 0.15m produced by company BestCon, Best, The Netherlands, was installed in March 2016 at a test site in Simpelveld, The Netherlands, and put into operation in August 2016 (see Fig. 7, tank under construction and tank in operation). Three out of the 15 applied prefab elements were cast with a dosage of 10 kg healing agent per m^3 concrete mix while the other 12 served as reference elements. To date (September 2019), after being more than 3 years in operation no sign of cracking or other forms of degradation or damage in both self-healing and reference type of elements has been observed. Therefore, although already fully functional for a 3-years period, as yet no conclusion can be drawn on possible benefits of using self-healing concrete in for this specific application. At best it can be concluded that so far no negative effects of the healing agent additive have been observed. Ongoing monitoring of element performance in the coming years will show if application of self-healing technology for this type of application will proof to be cost effective with respect to maintenance requirements and service life performance.

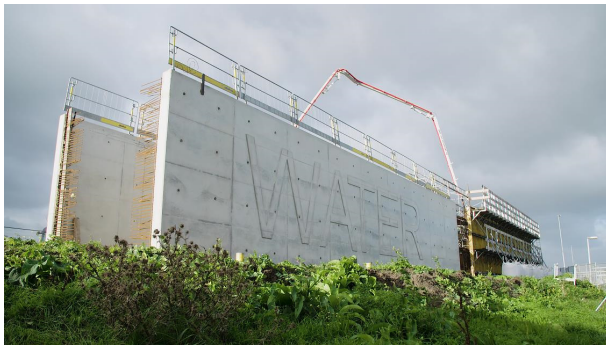
Figure 8. Full scale demonstrator in situ cast self-healing concrete water reservoir, Hoogvliet, The Netherlands.

The second full scale self-healing concrete demonstrator project involved an in situ cast rectangular concrete water reservoir. The tank, located in Hoogvliet, The Netherlands, was built in October 2017 by contractor BAM and commissioned by the Port of Rotterdam harbour authority and serves as fire extinguishing water reservoir. The reservoir is a rectangular concrete tank of 47 meters long, 5 meters high and 5.5 meters wide (Fig. 8). To enable determination of functional performance of self-healing concrete in comparison to traditional concrete, only half of the tank's concrete was amended with self-healing agent at a dosage of 5 kg/m^3 . Therefore two walls of the tank (South and

East facing) were made of self-healing concrete and the other two (North and West facing) of traditional concrete (same mix design without self-healing agent). The amount of applied steel reinforcement was equal in self-healing and reference concrete and was in accordance with design criteria to allow only occurrence of cracks with a maximum width of 0.1 mm. Because of strict water tightness constraints demanded by the owner, self-healing technology was used in this case as an additional precautionary measure to ensure water tightness of particularly the South facing wall (experiencing highest temperature fluctuations over time). The tank was filled with water in the summer of the year 2018, and during filling only minor non-leaking hairline cracks were observed in the North facing wall (not containing healing agent) but not in the other walls. To date, after being more than one year in full service, no actively leaking cracks have been observed in all walls. As such this demonstrator project has as yet not been successful as the aim was to compare crack-sealing efficiency of self-healing- versus traditional concrete walls. Like the first prefabricated wastewater treatment tank demonstrator project, also this in situ cast concrete reservoir will be monitored in the coming years to establish long-term water tightness and service life performance.
